# HL

**HL53K** 0,8 l/s, DN 50

**HL53KF** 0,5 l/s, DN 40

**DE** Duschrinne In|Floor  
**BG** ДУШ-КАНАЛ „In|Floor“  
**CS/SK** Sprchový žlab In|Floor  
**EN** Shower channel In|Floor  
**HR** Tuš kanalica In|Floor  
**HU** In|Floor zuhanyfolyóka

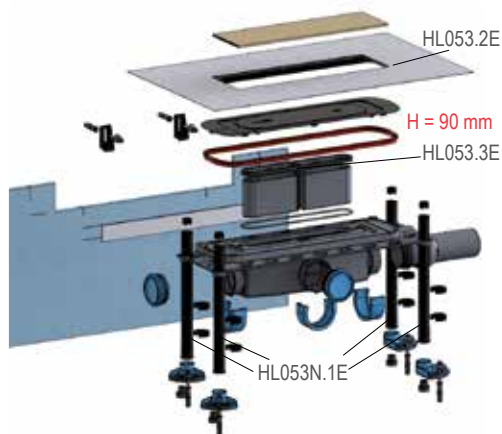
**HL53K** 0,8 l/s, DN 50

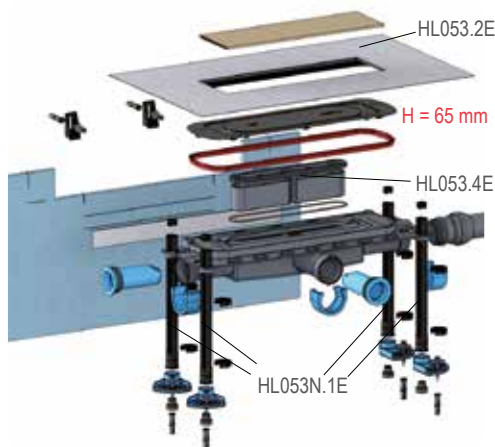
**HL53KF** 0,5 l/s, DN 40

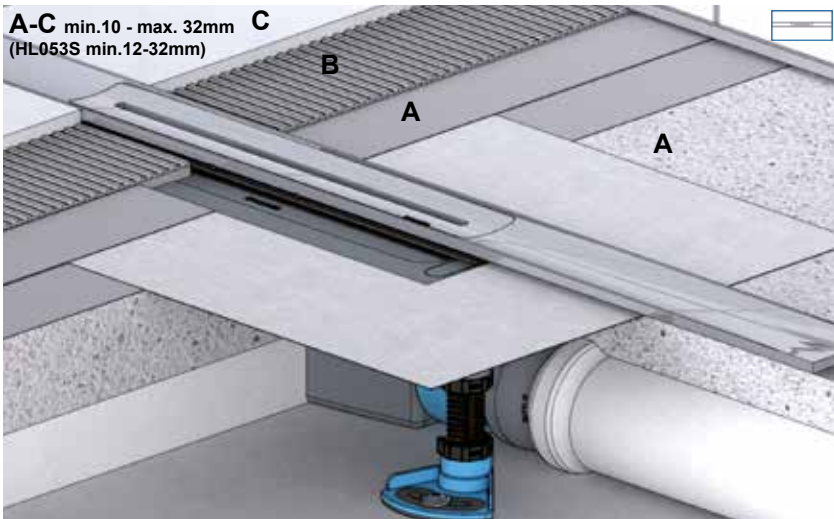
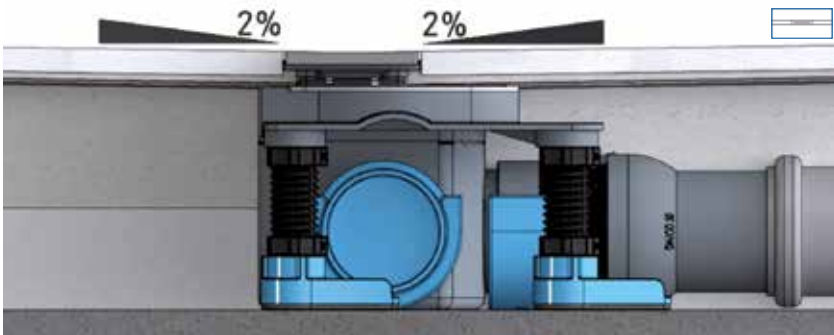
**A-C min.10 - max. 32mm C**  
(HL053S min.12-32mm)

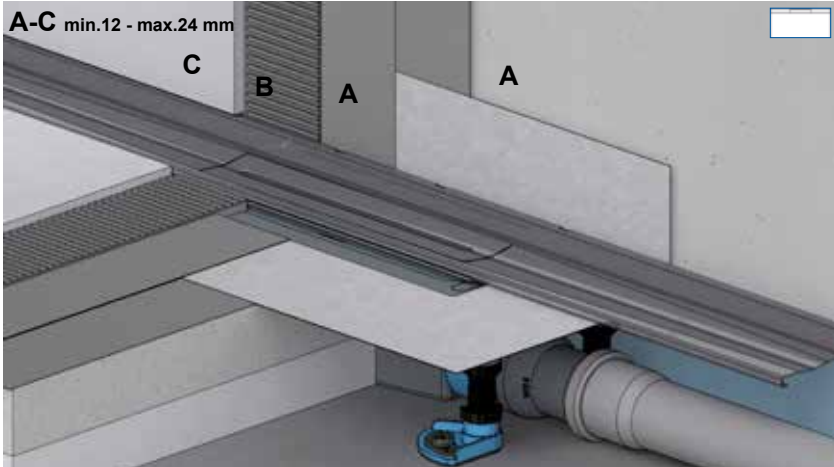
**A-C min.12 - max.24 mm**
